DOCUMENT NO. D290-75303-2 Vol. III

TITLE IUS Program: Shock Analyses and Shock Tests

This volume of D290-75303-2 contains shock analysis and shock test results performed in support of the Inertial Upper Stage (IUS) program.

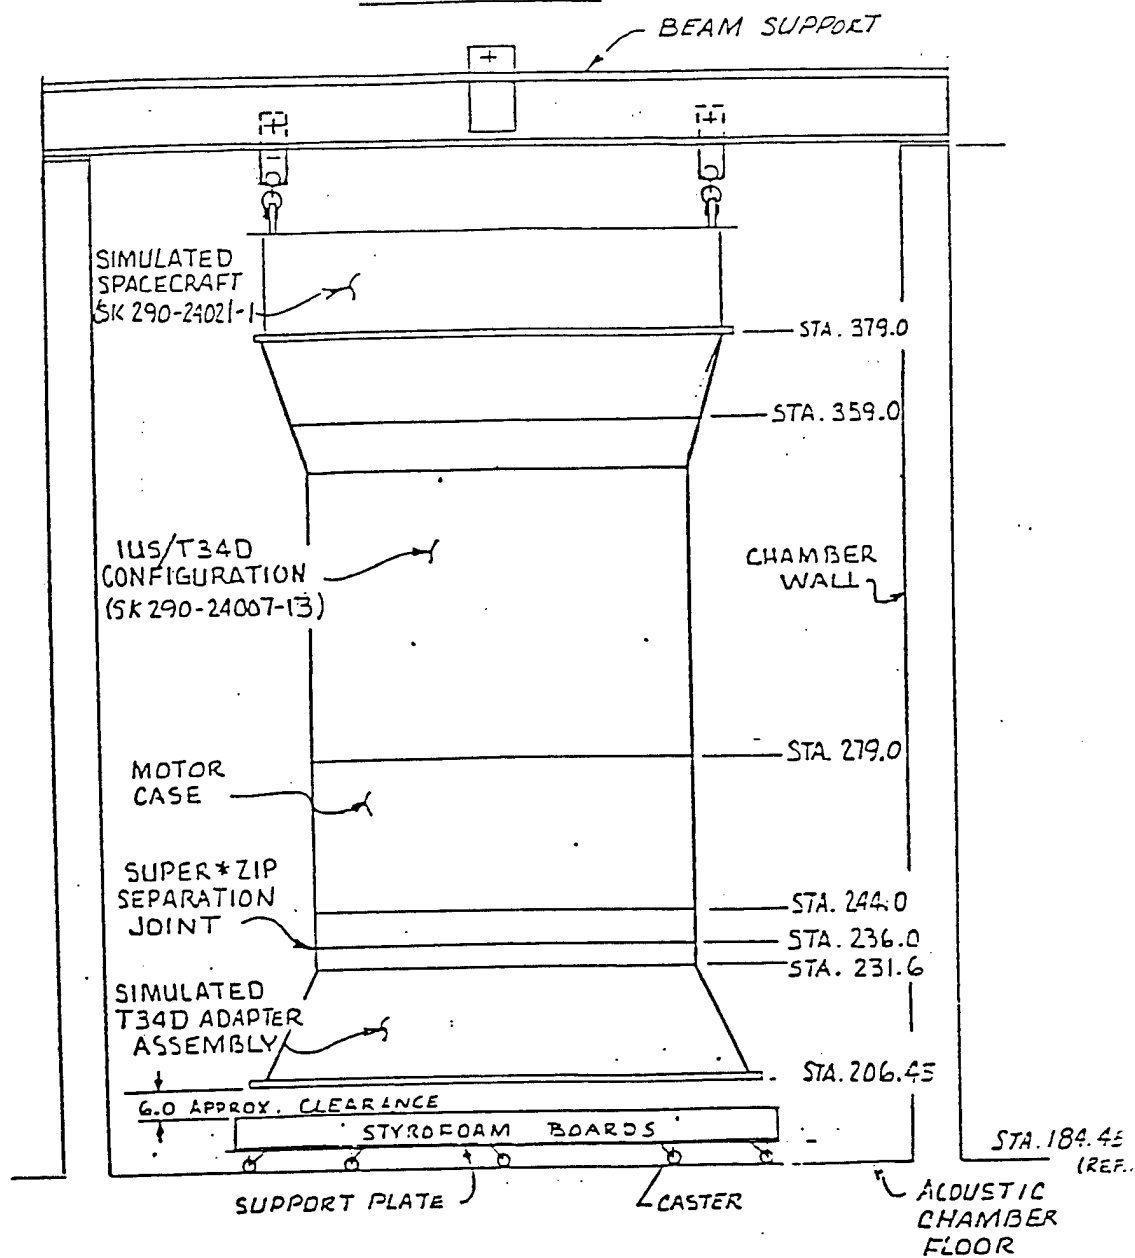
FIGURE 1

TEST SETUP - TITAN/IUS (T34D/DTV) SEPARATION SHOCK TEST

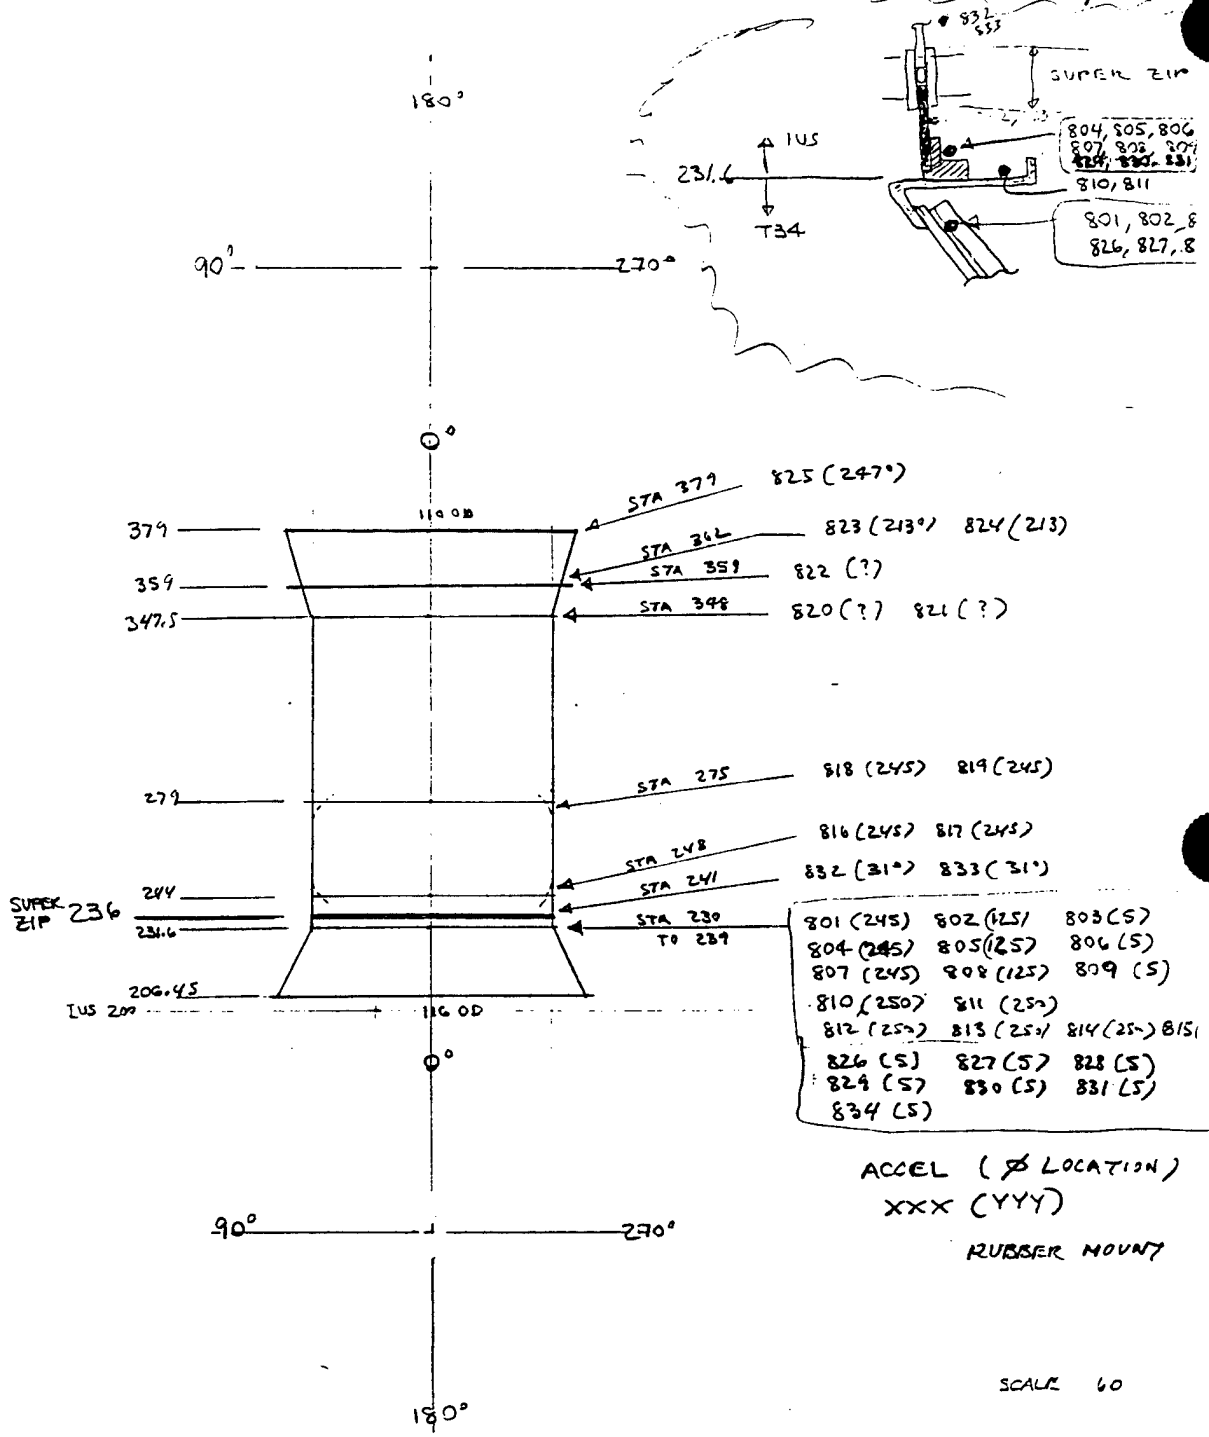
SUMMARY OF SHOCK ENVELOPES
T340/INS SEPARATION PYROTECH.
4/3/79

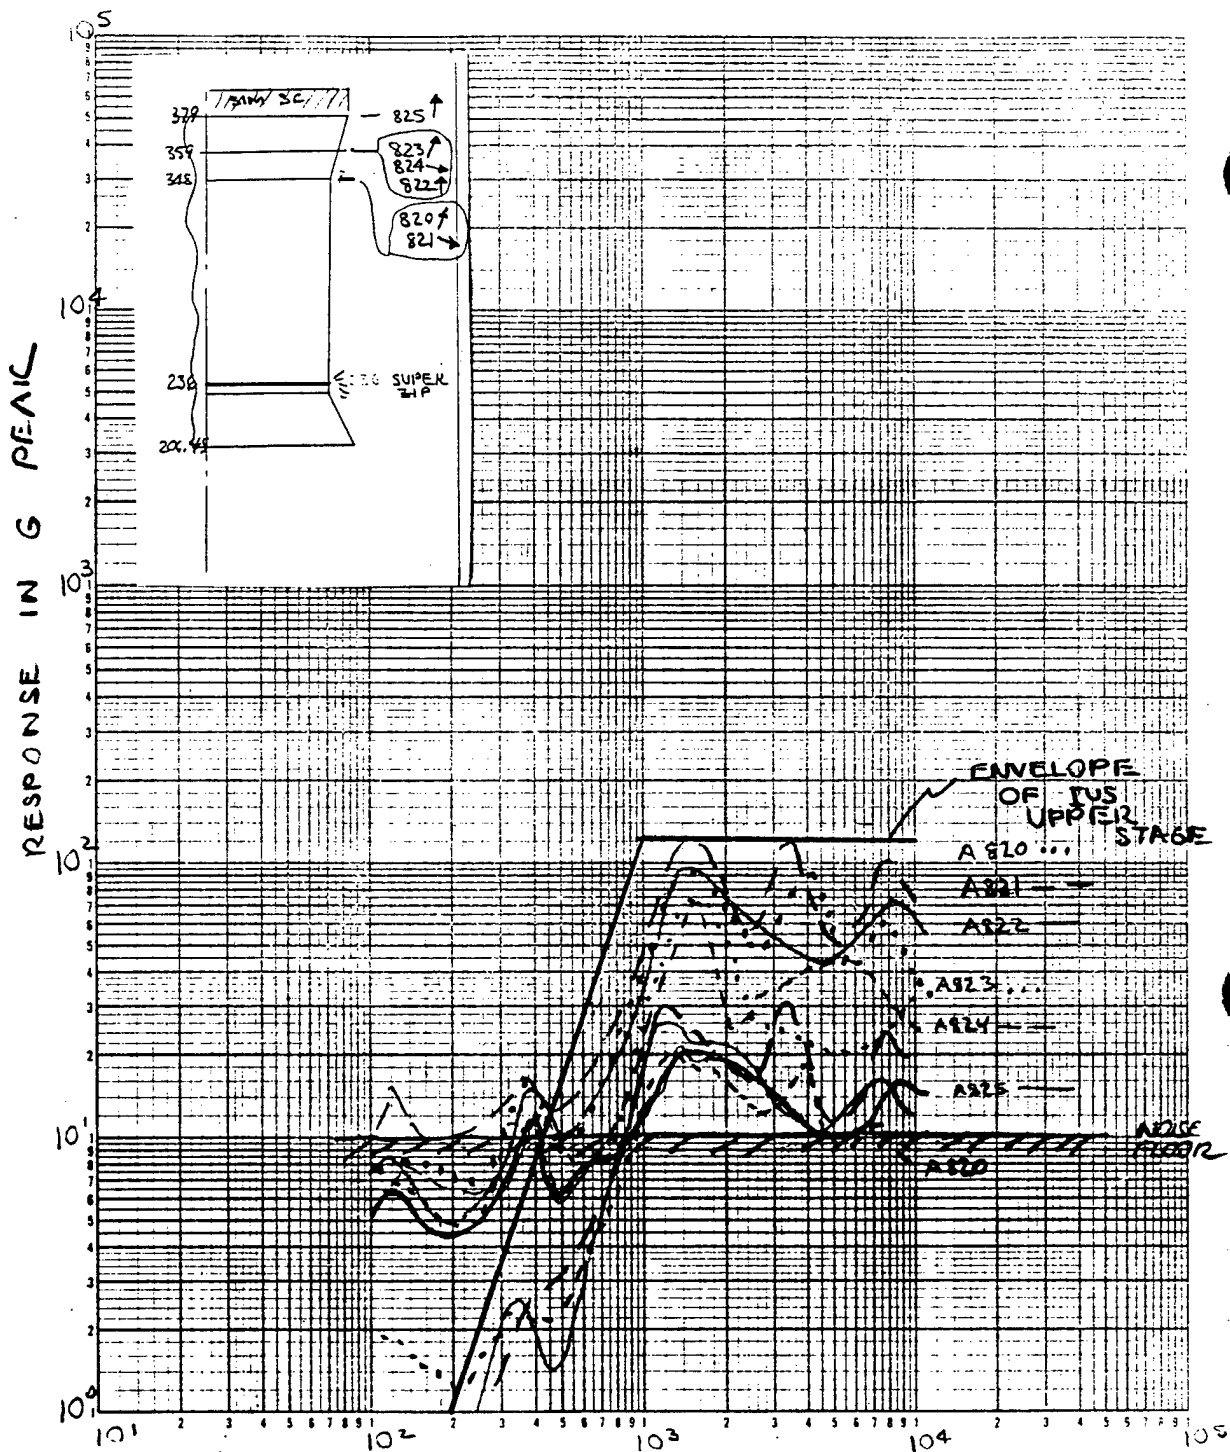
SHEET (4)

CALC	213	4/13/77	FIG (A) TPR 2-5693-7800-117
CHECK			RESPONSE OF UPPER IUS TO
APPD			T340/ IUS SEPARATION, SUPER ZIP
APPD

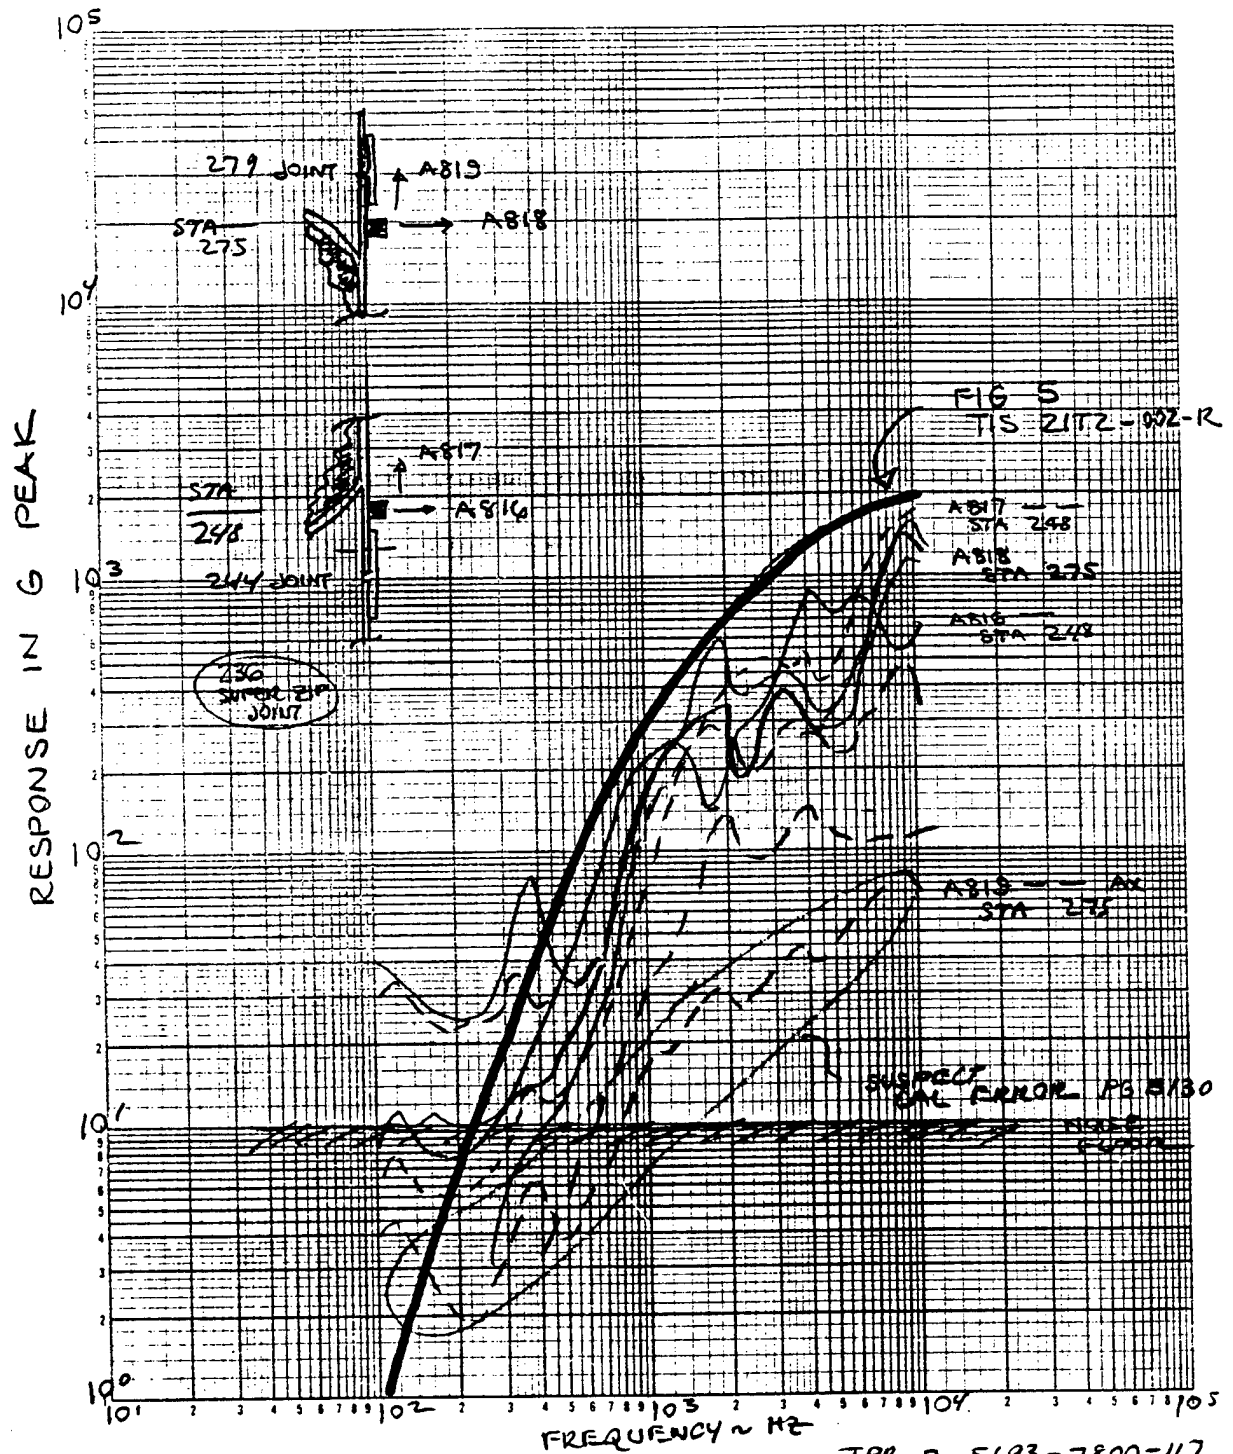
SHF5 (5)

FIG (B) RESPONSE OF SRM 1
MOTOR CASE TO
T34D/ IUS SEPARATION

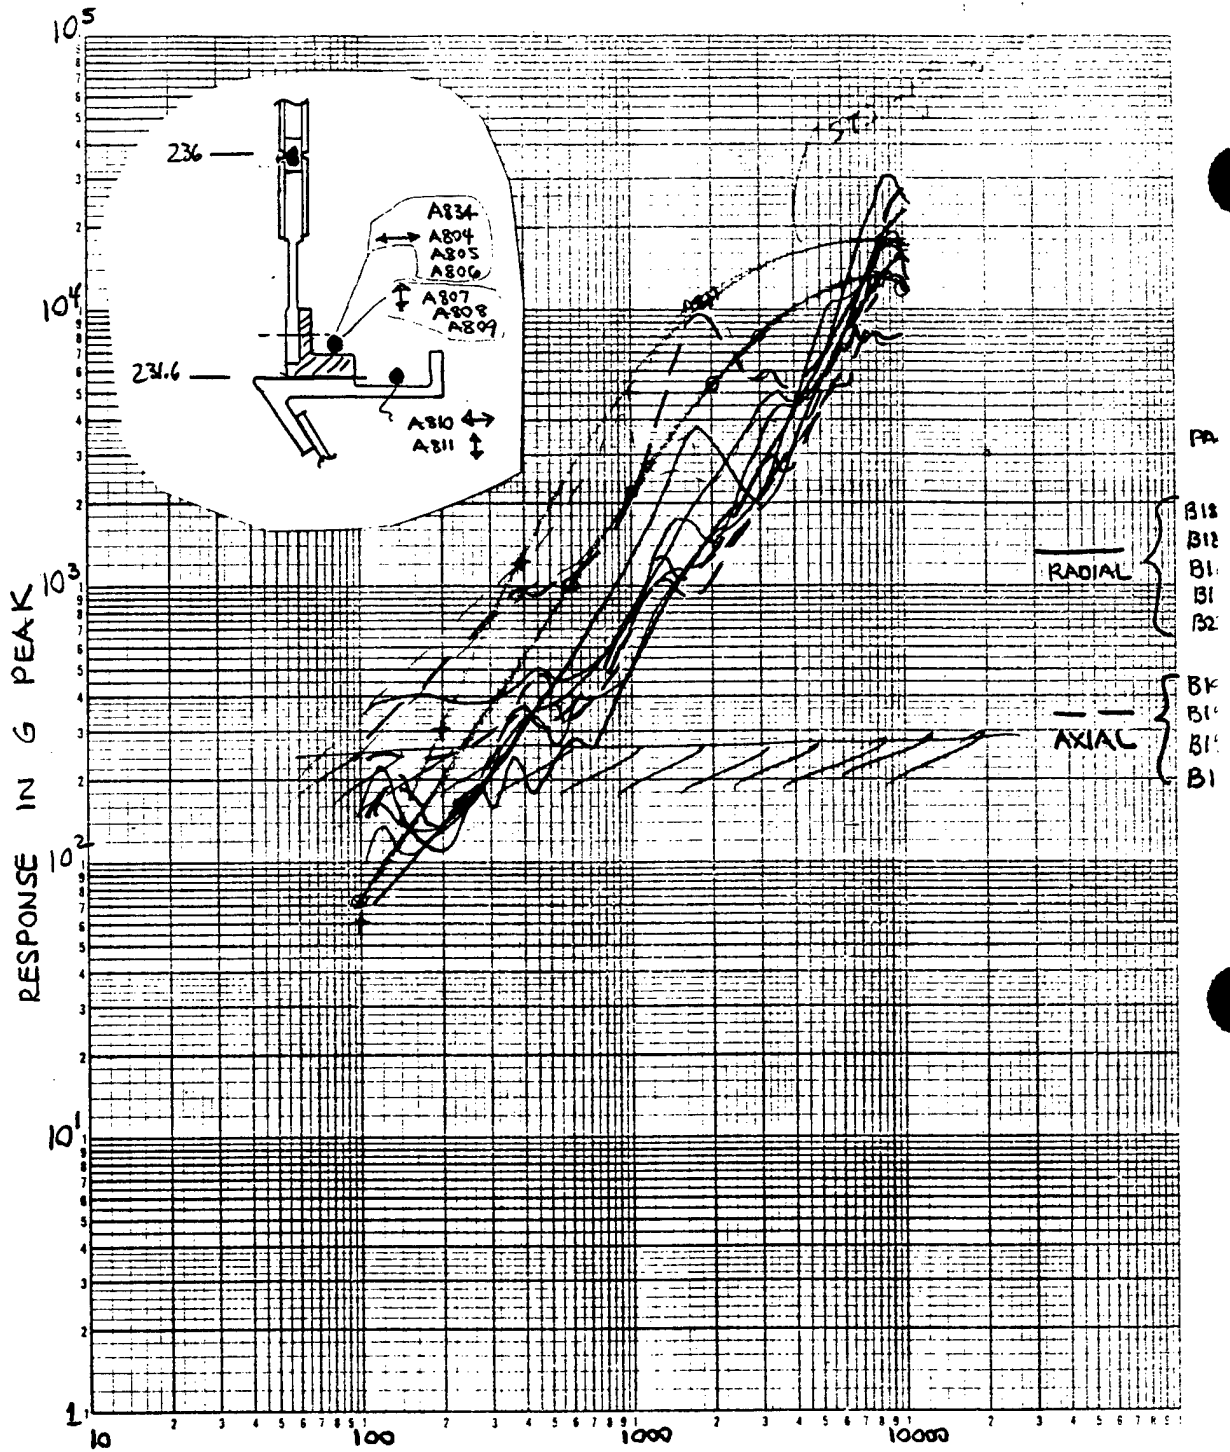
SHEET 6

FREQ HZ TPR 2-5693-7800-117
 FIG C RESPONSE OF STRUCTURE
 NEAR T340/IUS JOINT
 TO T340/IUS SEPARATION

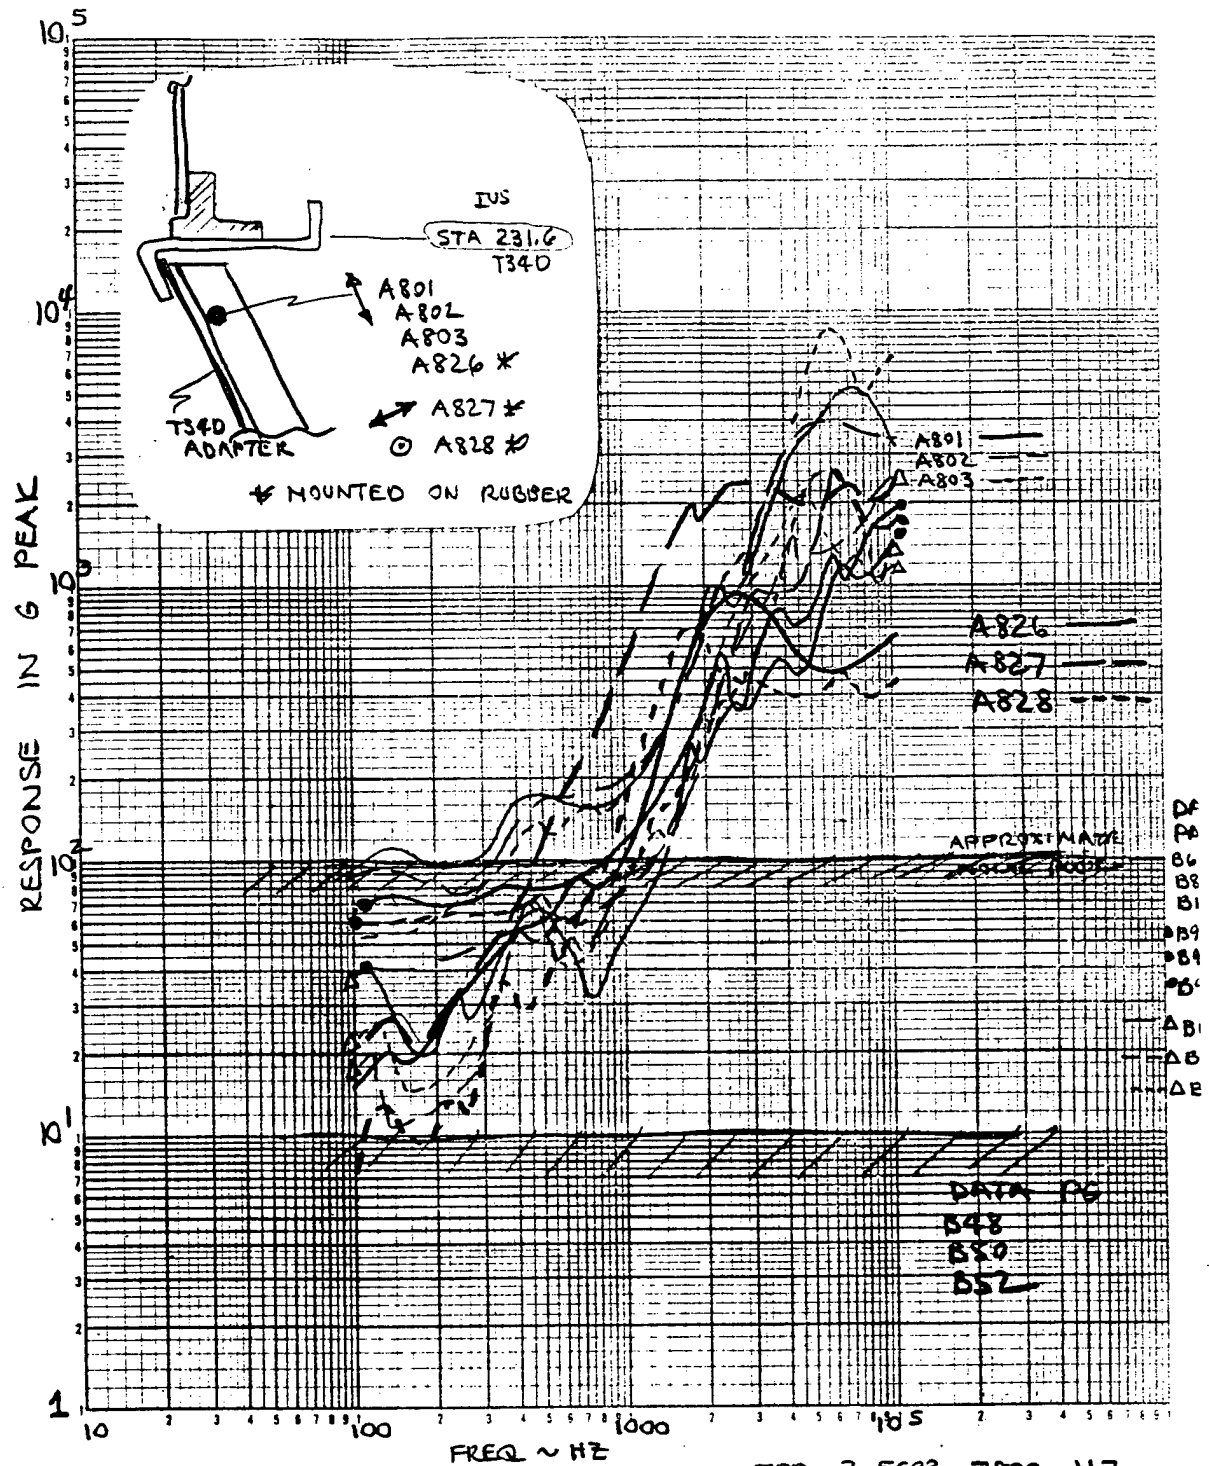
SHEET ⑦

CALC	0/3	1/27/79			FIG ① RESPONSE OF T34D ADAPTER TO T34D/IUS SEPARATION	
CHECK						
APPD						
APPD

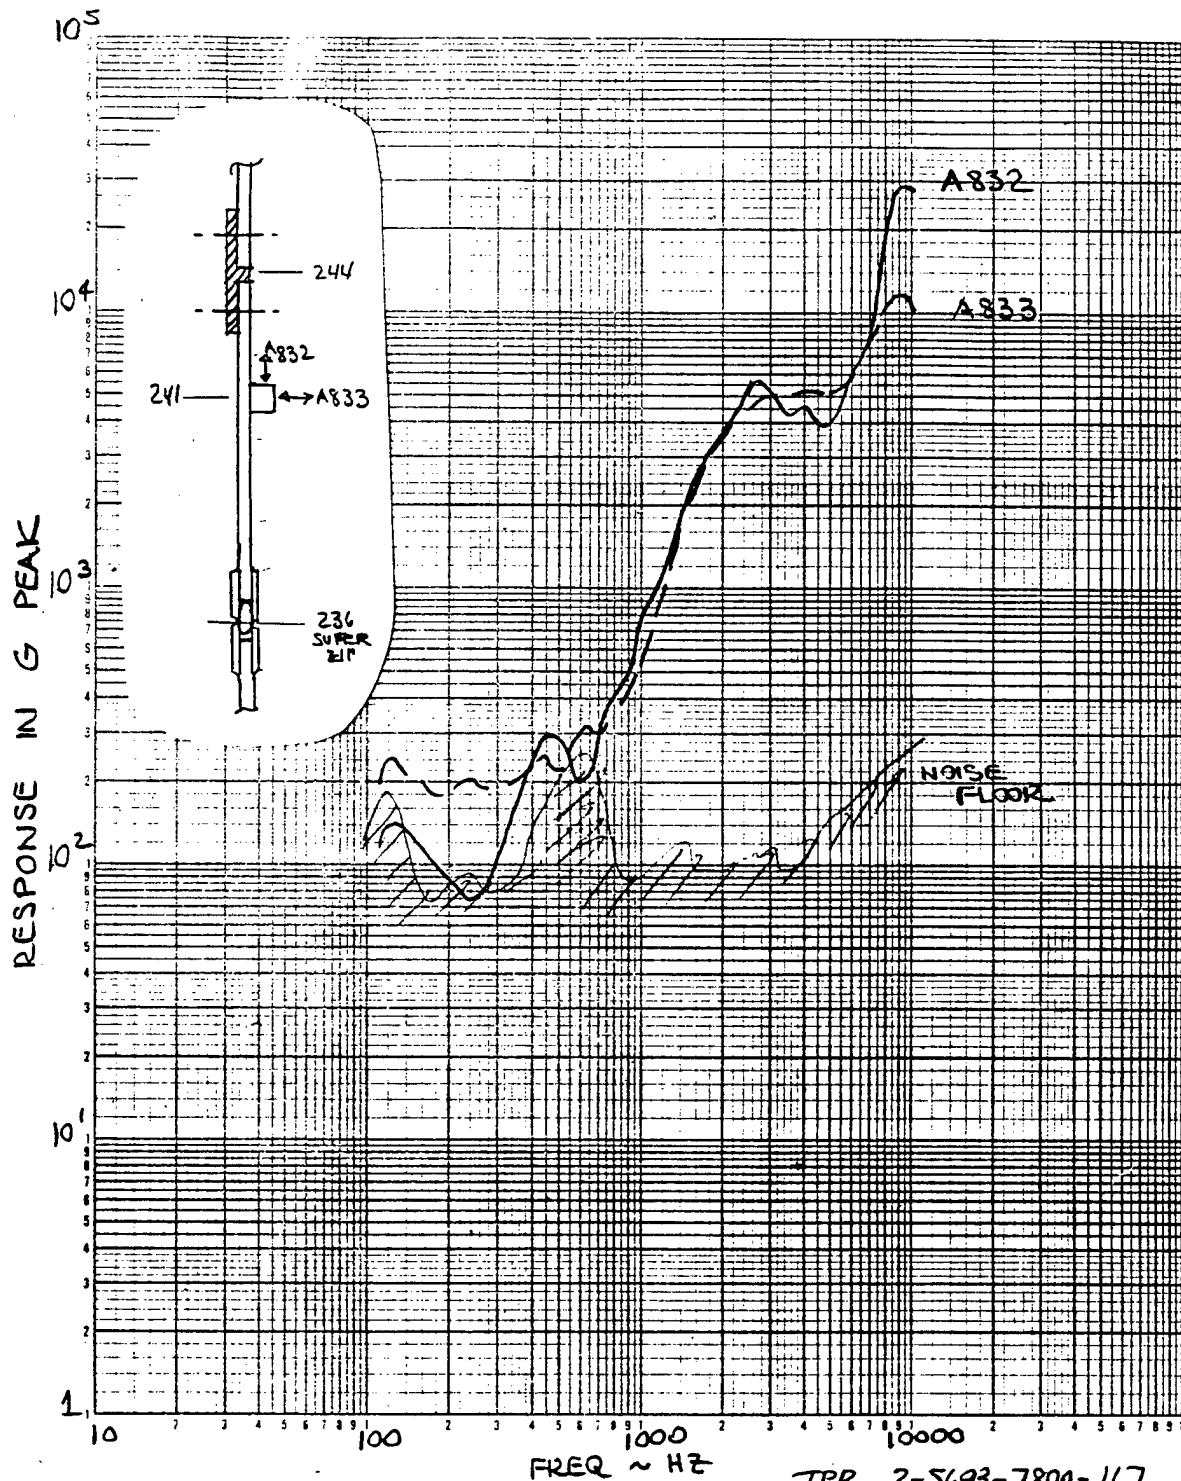
SHEET 8

CALC	OPack 4/2/77	FIG (E) STRUCTURE RESPONSE	TPR 2-5693-7800-117
CHECK		WITHIN 5 INCHES OF	
APPD		SUPER ZIP	
APPD

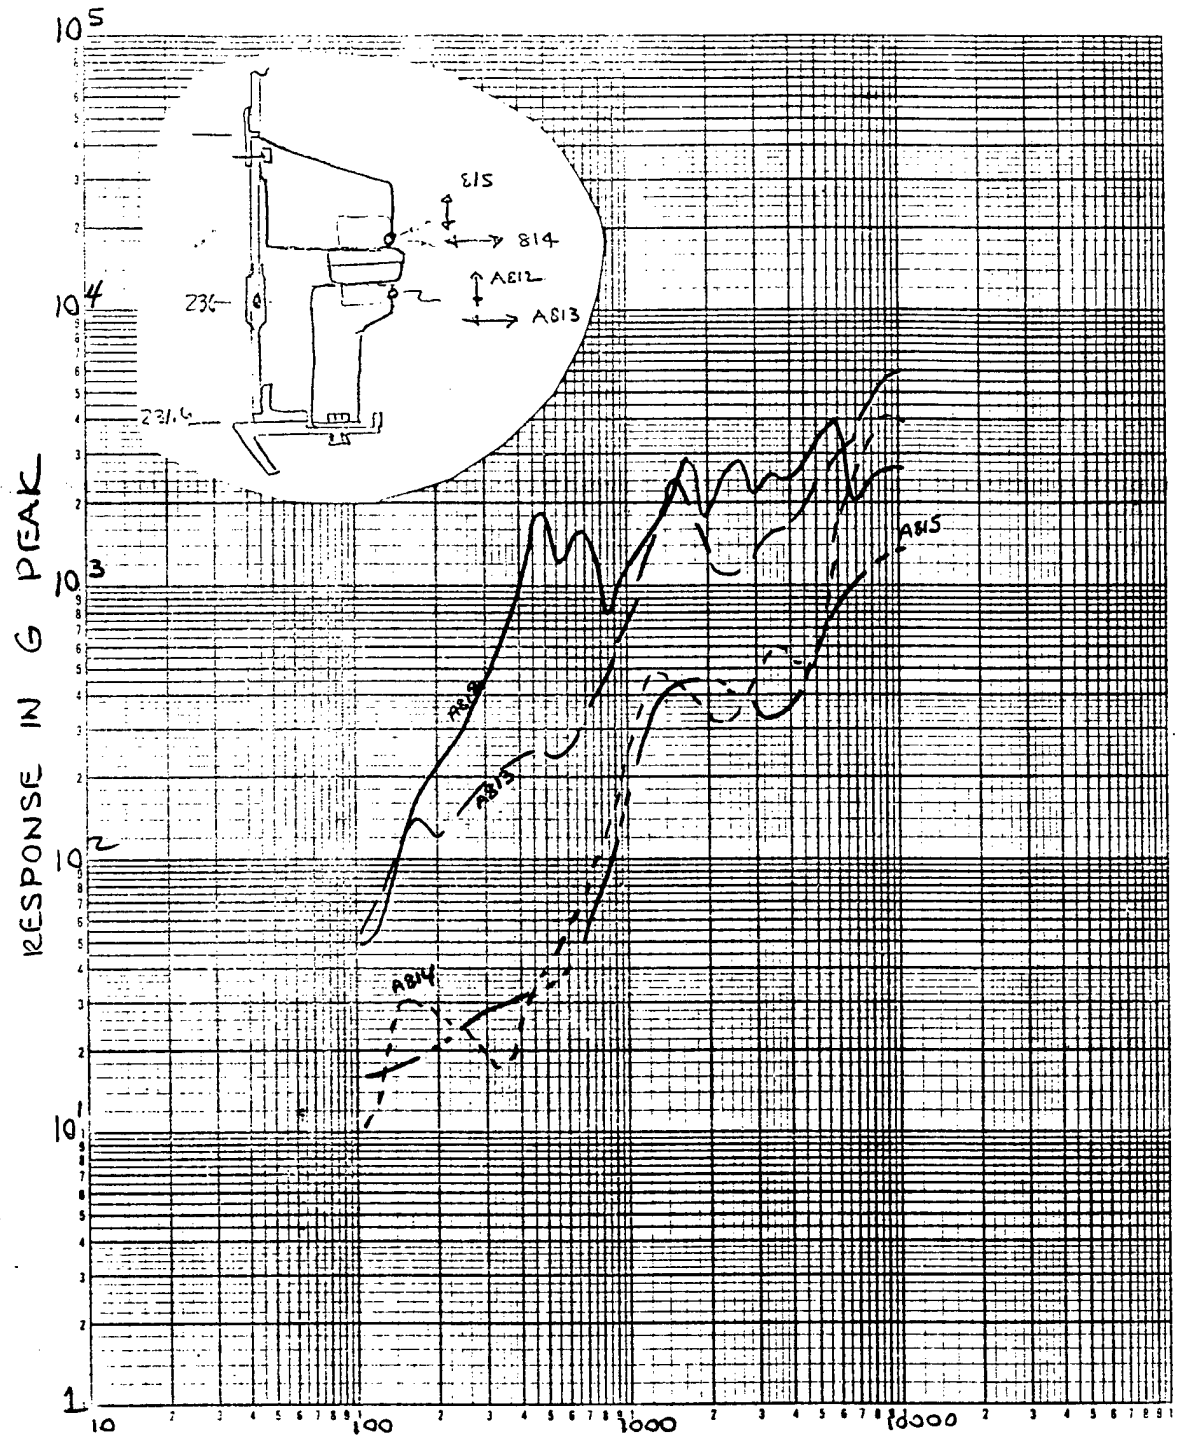
SHFF 9

RESPONSE OF CONNECTORS
TO T34D IUS SEPARATION

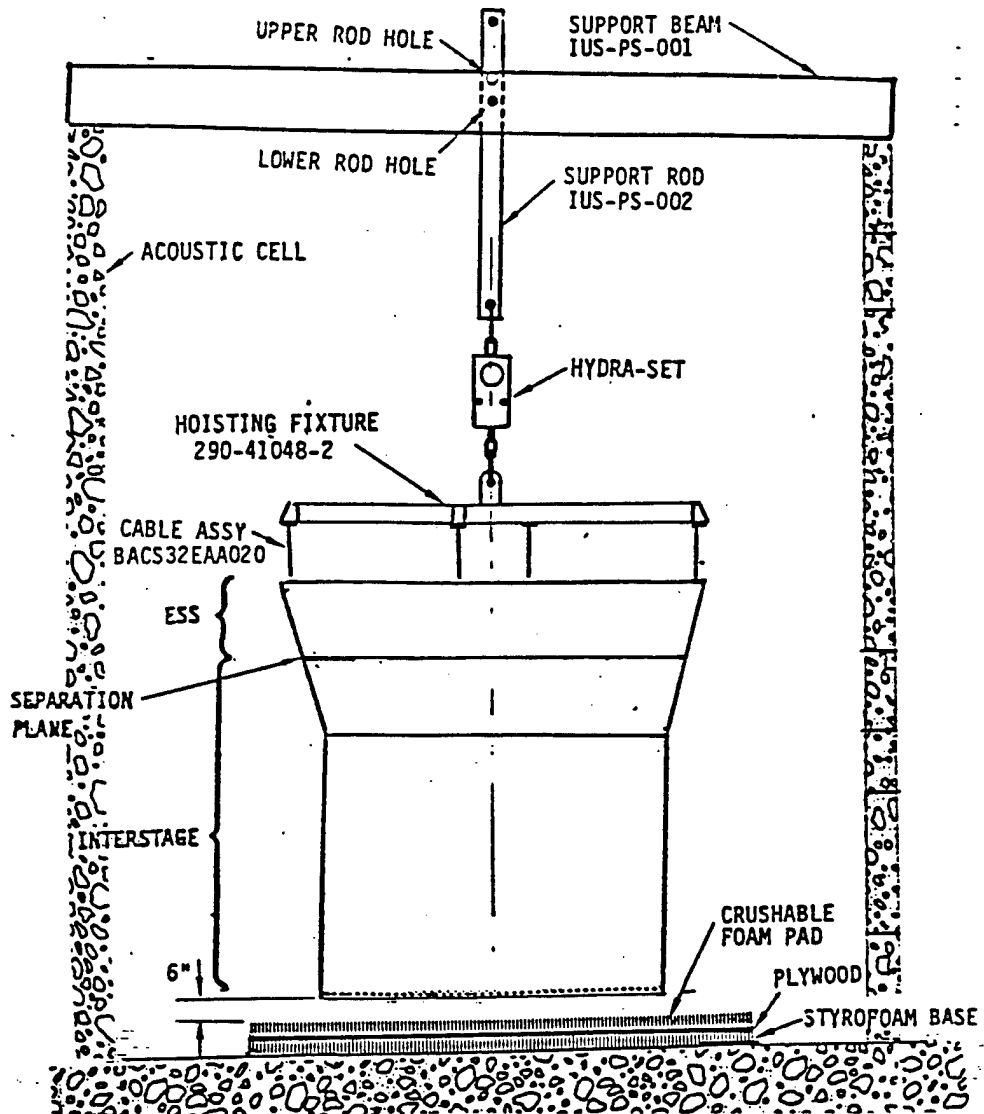
FIGURE 2-1 IUS QTV TEST CONFIGURATION

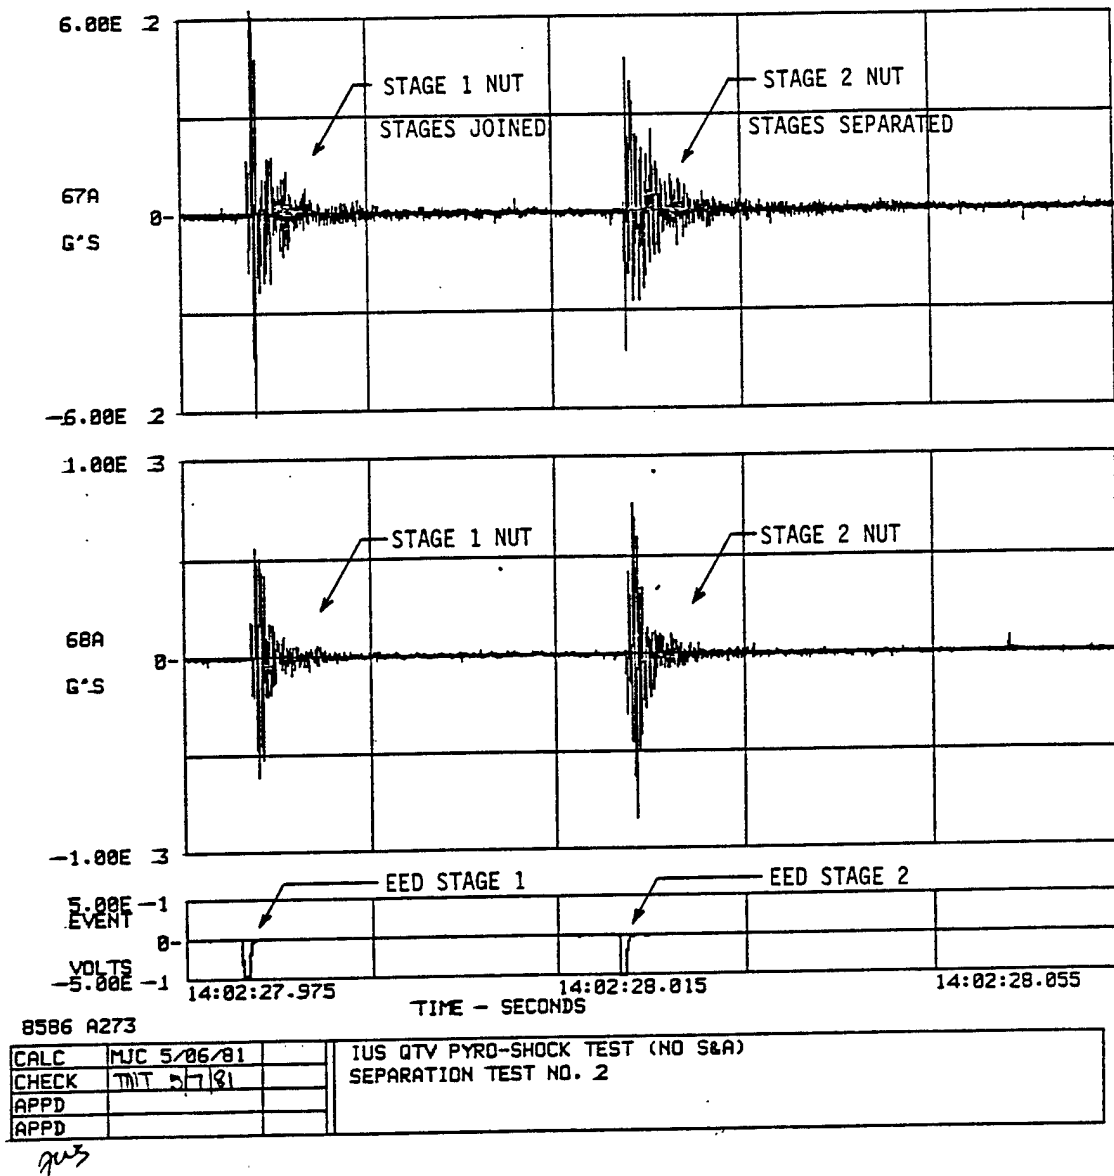
FIGURE 2-3 SHOCK TIME HISTORIES

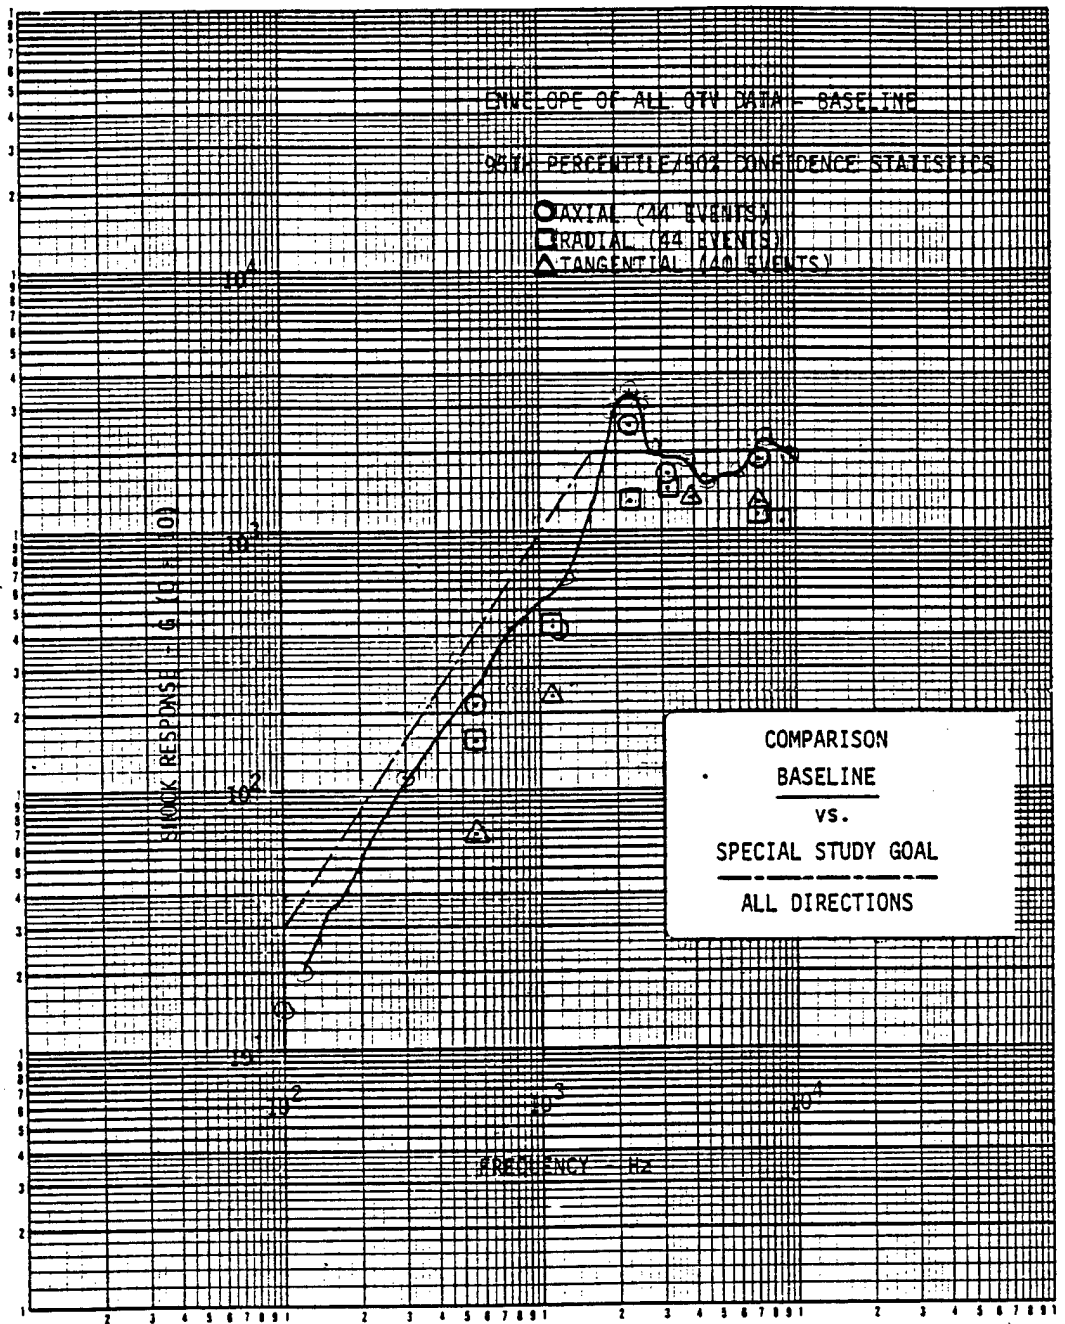
FIGURE 2-14

CALC	<i>C. Beck</i>	9/24/81			IUS INDUCED SHOCK ENVIRONMENT BASELINE IUS/SPACECRAFT INTERFACE	
CHECK						
APPO						
APPO

The Baseline Shock Environment is less than the Special Study Goal except for two frequency ranges, see Figure 2-14. Cost estimates and schedules were not obtained for any of the shock reduction techniques since the Baseline Environment essentially meets the Special Study Goal.

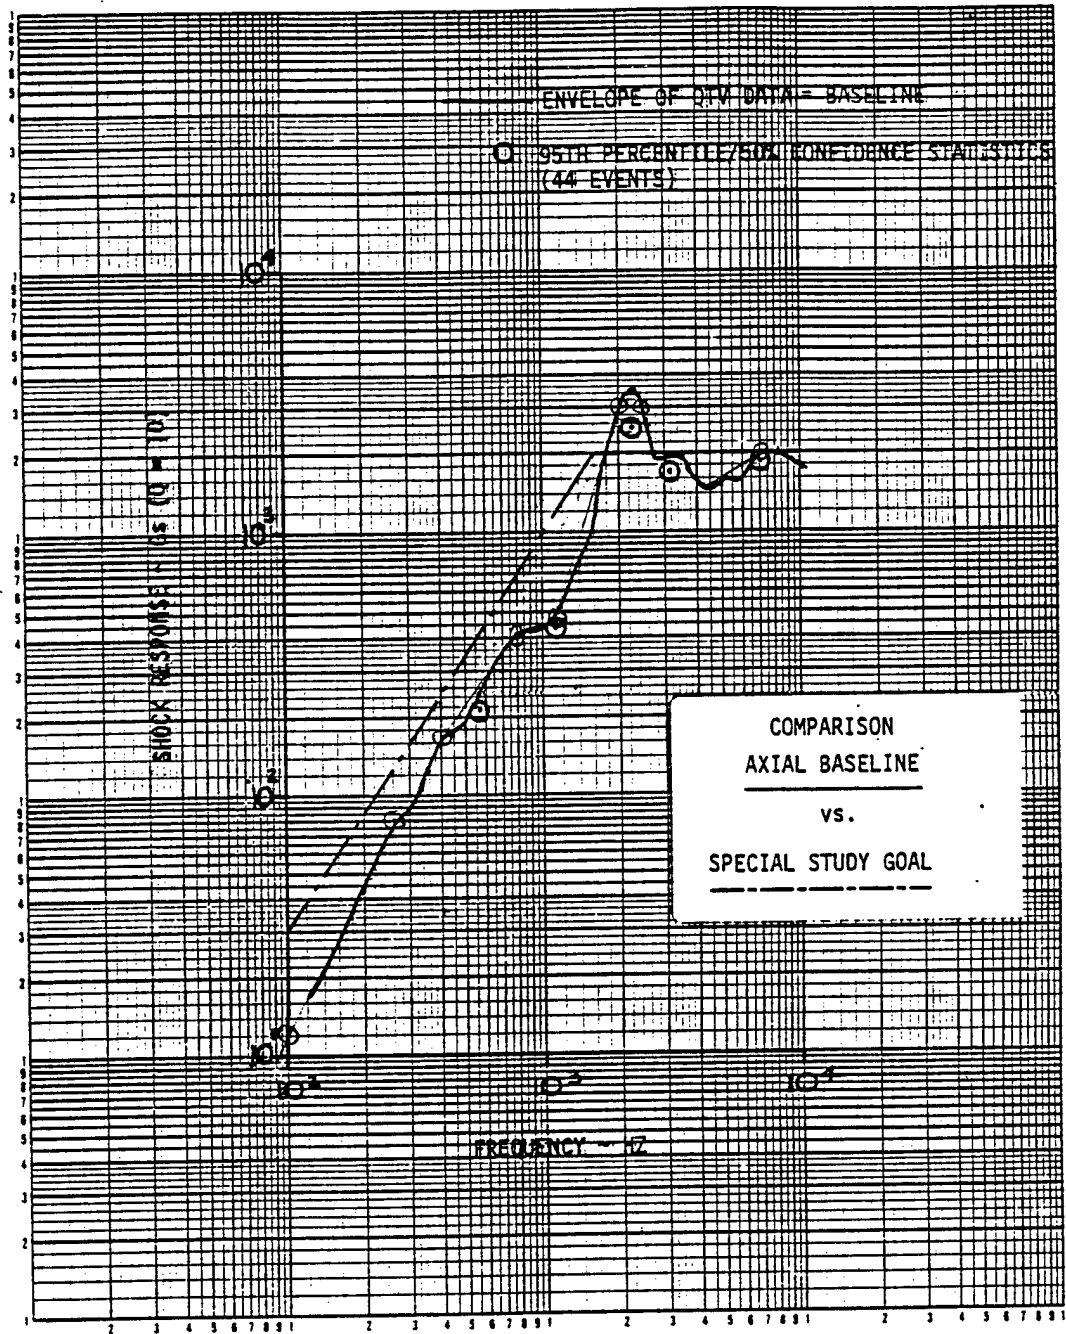
FIGURE 2-15

CALC	Q3RCK 9/12/81				IUS INDUCED SHOCK ENVIRONMENT	
CHECK					IUS/SPACECRAFT INTERFACE	
APPO					AXIAL DIRECTION	
APPO

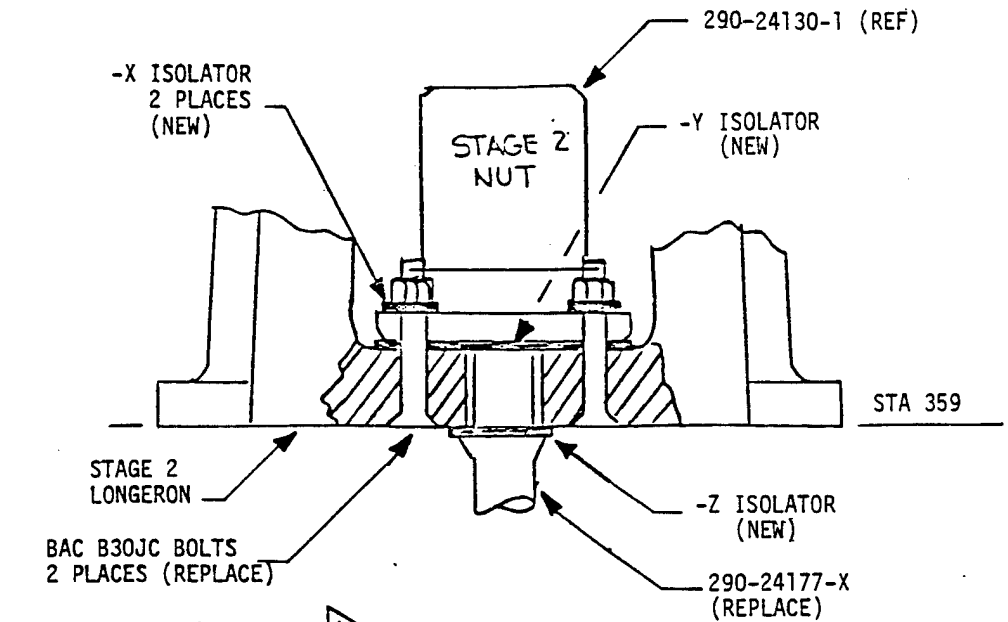
FIGURE 3-3
STAGE 2 NUT ISOLATION DESIGN

MATERIAL LIST			
CATEGORY	PART NO.	QTY	DESCRIPTION
NEW	-X	2	Isolating washer assy .75 OD, .38 ID, 1 thick Material 1
NEW	-Y	1	Isolating washer assy 2 OD, 1 ID, 1 thick Material 1
NEW	-Z	1	Isolating washer assy 1.5 OD, 1 ID, 1 thick Material 1
REPLACE	290-24177-X	1	Similar to 290-24177-1, increase length
REPLACE	BACB30JC	2	Increased length

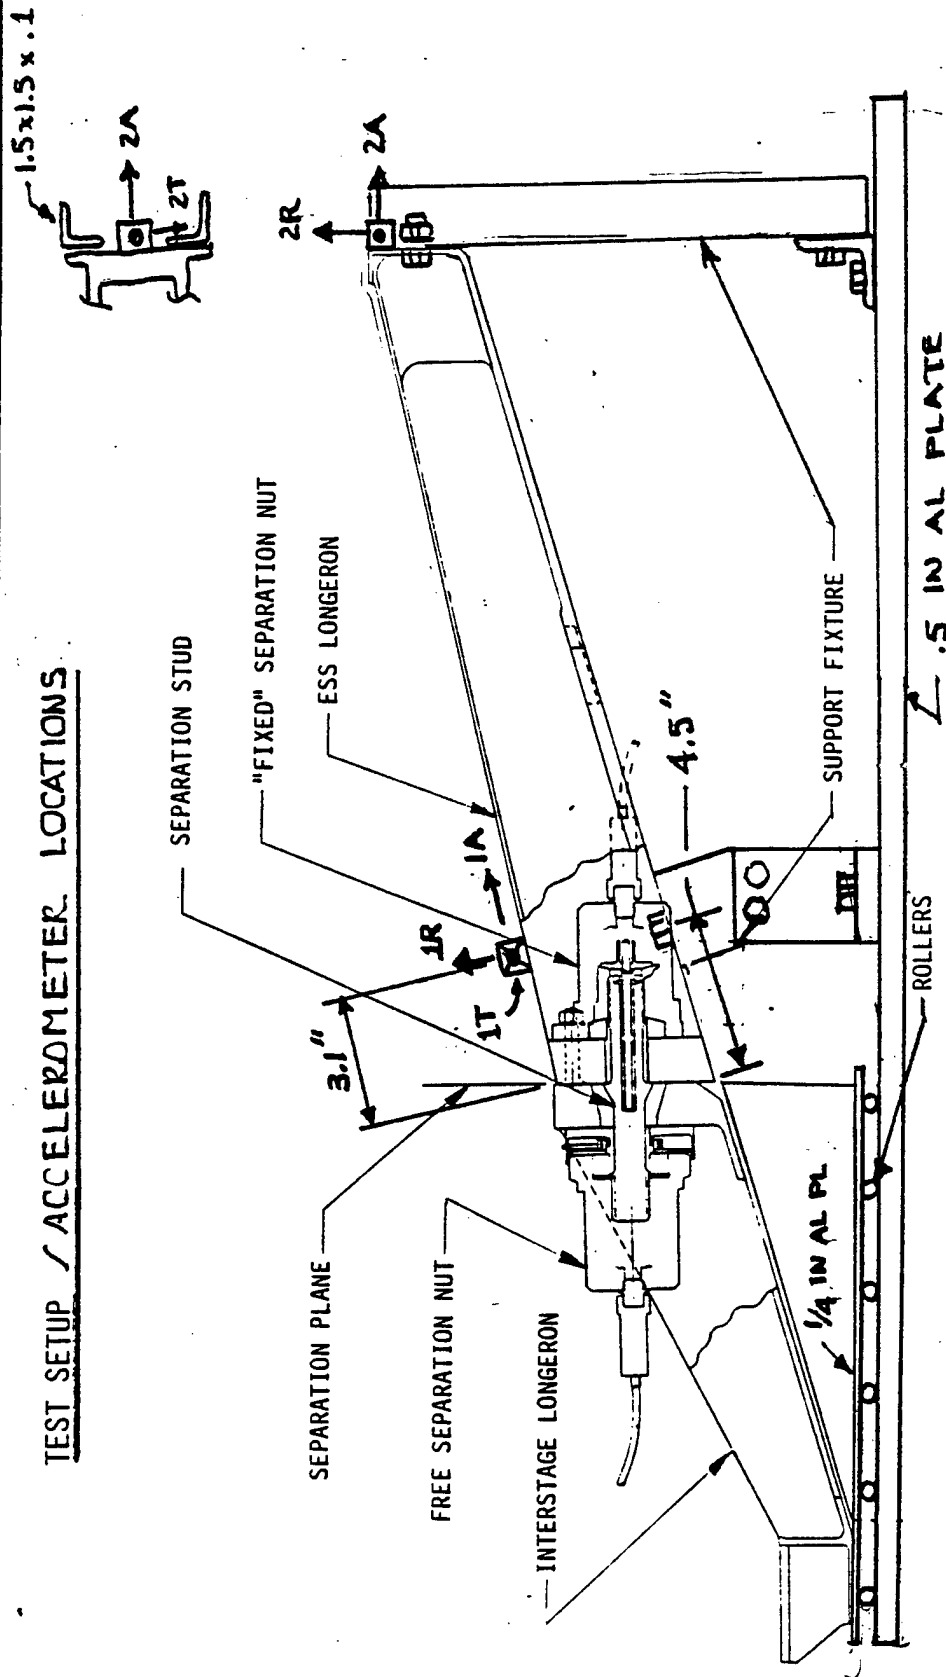
FIGURE 1

TEST SETUP / ACCELEROMETER LOCATIONS

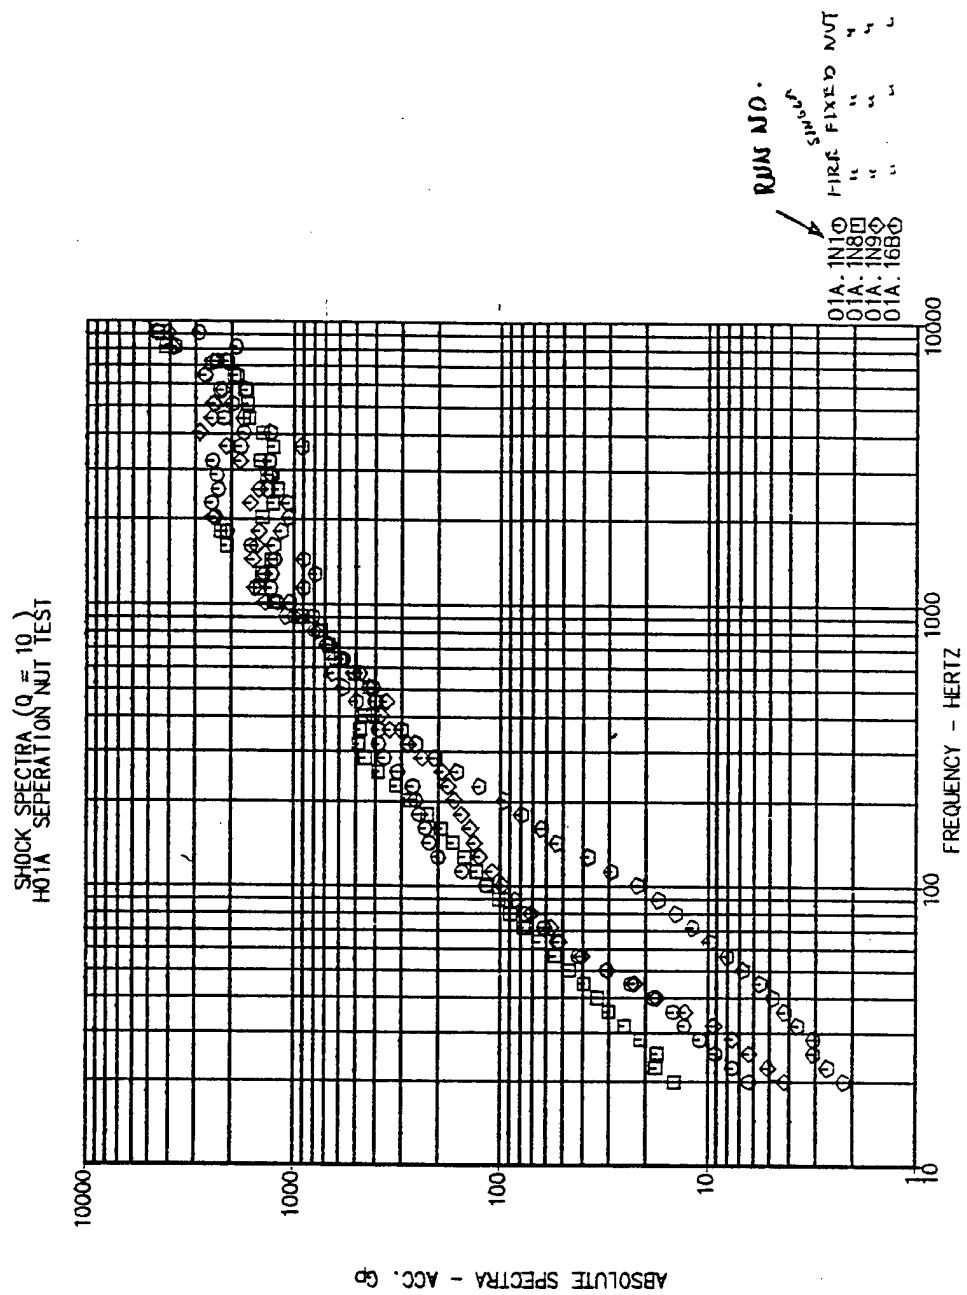
FIGURE 2. SINGLE FIXED NUT FIRING LOCATION 1 AXIAL
